ALABAMA DEPARTMENT OF TRANSPORTATION

Annual Inspection Report Bessemer Municipal Airport

ANNUAL INSPECTION REPORT

BESSEMER MUNICIPAL AIRPORT BESSEMER, ALABAMA

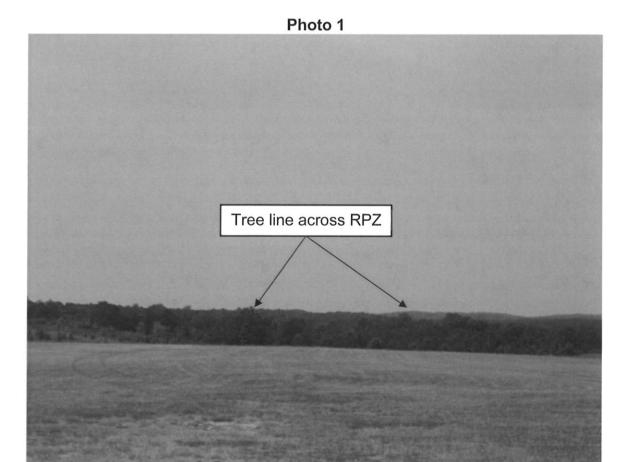
- → Runway 5 A line of trees across the southern side of the FAA Runway Protection Zone violate the required 50:1 slope, reducing the slope to 28:1. (See Appendix 2 for location)
- → Runway 23 Trees located along the northern side and the center of the FAA Runway Protection Zone violate the required 34:1 slope, reducing the slope to 8:1. (See Appendix 3 for location)

Runway 5 Approach

→ In order to meet certain FAA grant assurances the obstructions located within the FAA 50:1 approach slope for runway 5 should be cleared.

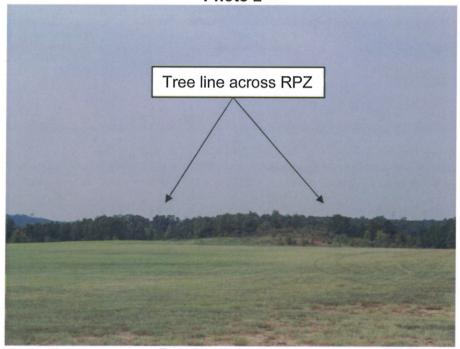
Photo 2

Runway 5 Approach

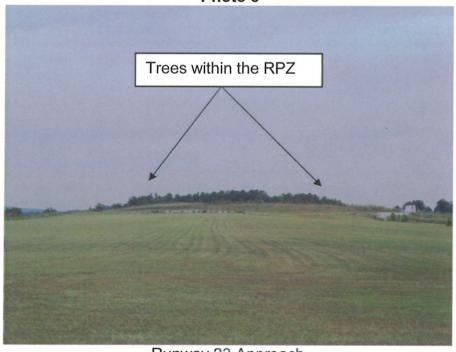
Photo 3

Runway 23 Approach

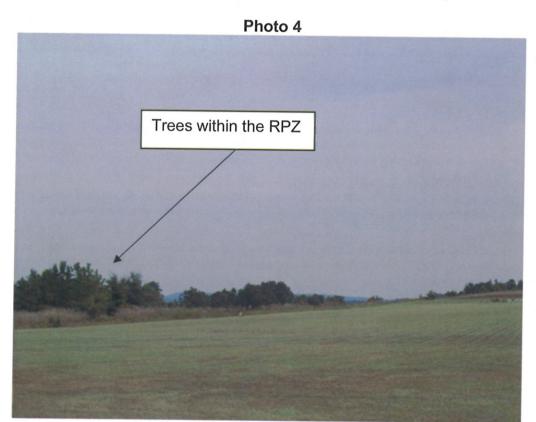
Runway 23 Approach

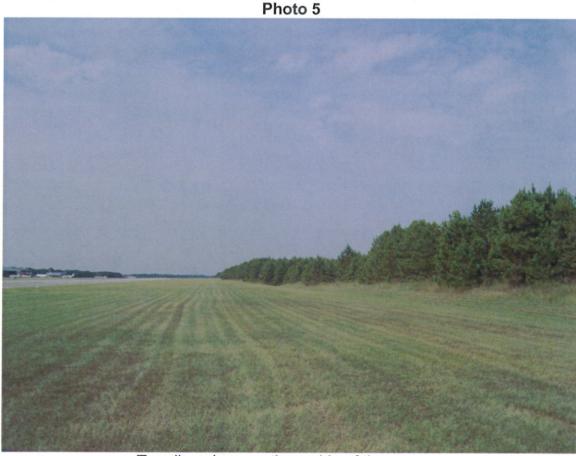
Trees along the northern edge of the entire runway are located within the FAA Object Free Area which is located 250 feet each side of centerline and extends past the runway end 300 feet. Trees are located 147 feet to 180 feet from the centerline of the runway.

Tree line along northern side of the runway

→ Remove all obstructions to the FAA Object Free Area.

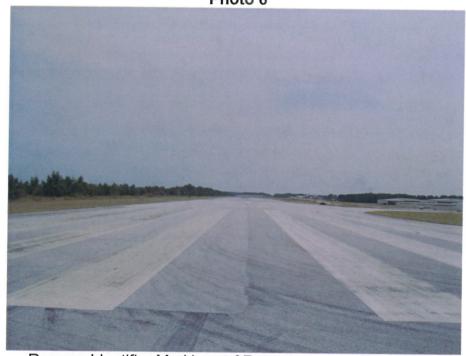
Runway Identifier Markings of Runway 5 in FAIR condition

→ The runway markings must be remarked in accordance with FAA AC150/5340-1J "Standards for Airport Markings" in the near future. Plans should be made to have this maintenance item funded within the next two years.

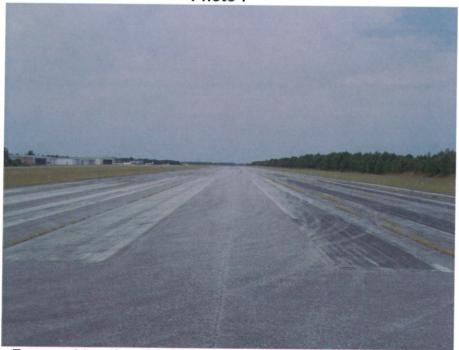
Photo 7

Runway Identifier Markings of Runway 23 in POOR condition

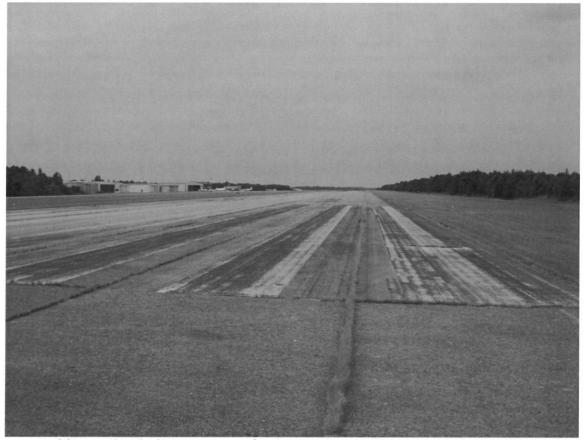
The runway surface has minor raveling and joint cracking with vegetation in the paving seams. This condition was not noted on the newer pavement of the runway extension, but was noted on the old pavement particularly near the Runway 5 threshold.

Vegetation in lane seams of pavement near Runway 23 threshold.

→ Vegetation must be removed and the cracks cleaned and sealed.

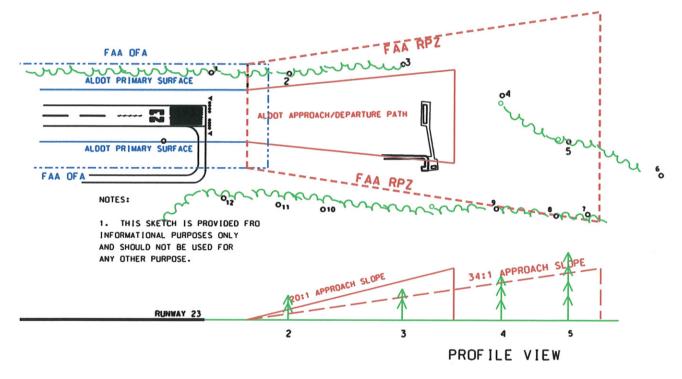
PLAN AND PROFILE RUNWAY 23

VIOLATIONS OF THE 34:1 SLOPE

- 2. +24 FOOT TREE 401 FEET FROM RUNWAY END 205 FEET FROM CENTERLINE 8:1 SLOPE
- 3. +30 FOOT TREE 951 FEET FROM RUNWAY END 251 FEET FROM CENTERLINE 25:1 SLOPE
- 4. +42 FOOT TREE 1430 FEET FROM RUNWAY END 102 FEET FROM CENTERLINE 29:1 SLOPE
- 5. +65 FOOT TREE 1751 FEET FROM RUNWAY END 120 FEET FROM CENTERLINE 23:1 SLOPE
